# **STABILIZATION AND UPGRADING OLD TRANSPORTATION TUNNELS**

**by  
Rich Humphries and Mark Sandfort**

**Golder Associates**

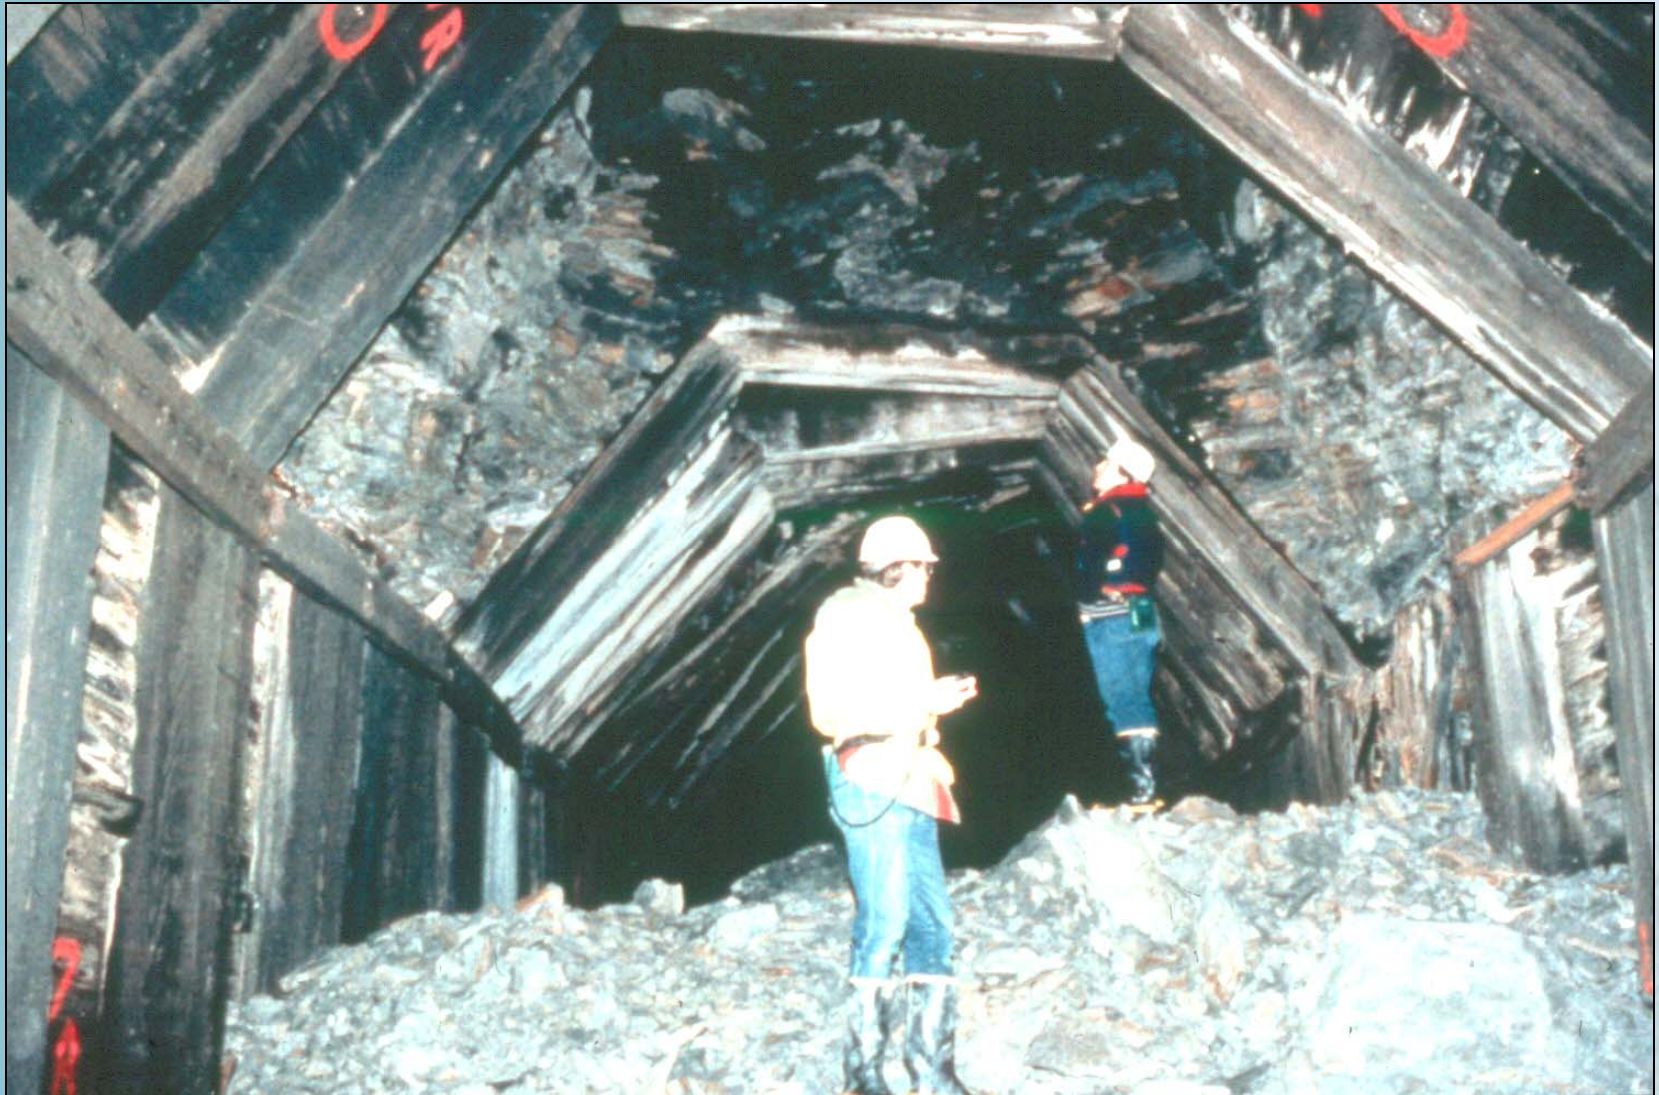
# Little Tunnel – Initial Collapse of Wooden Sets

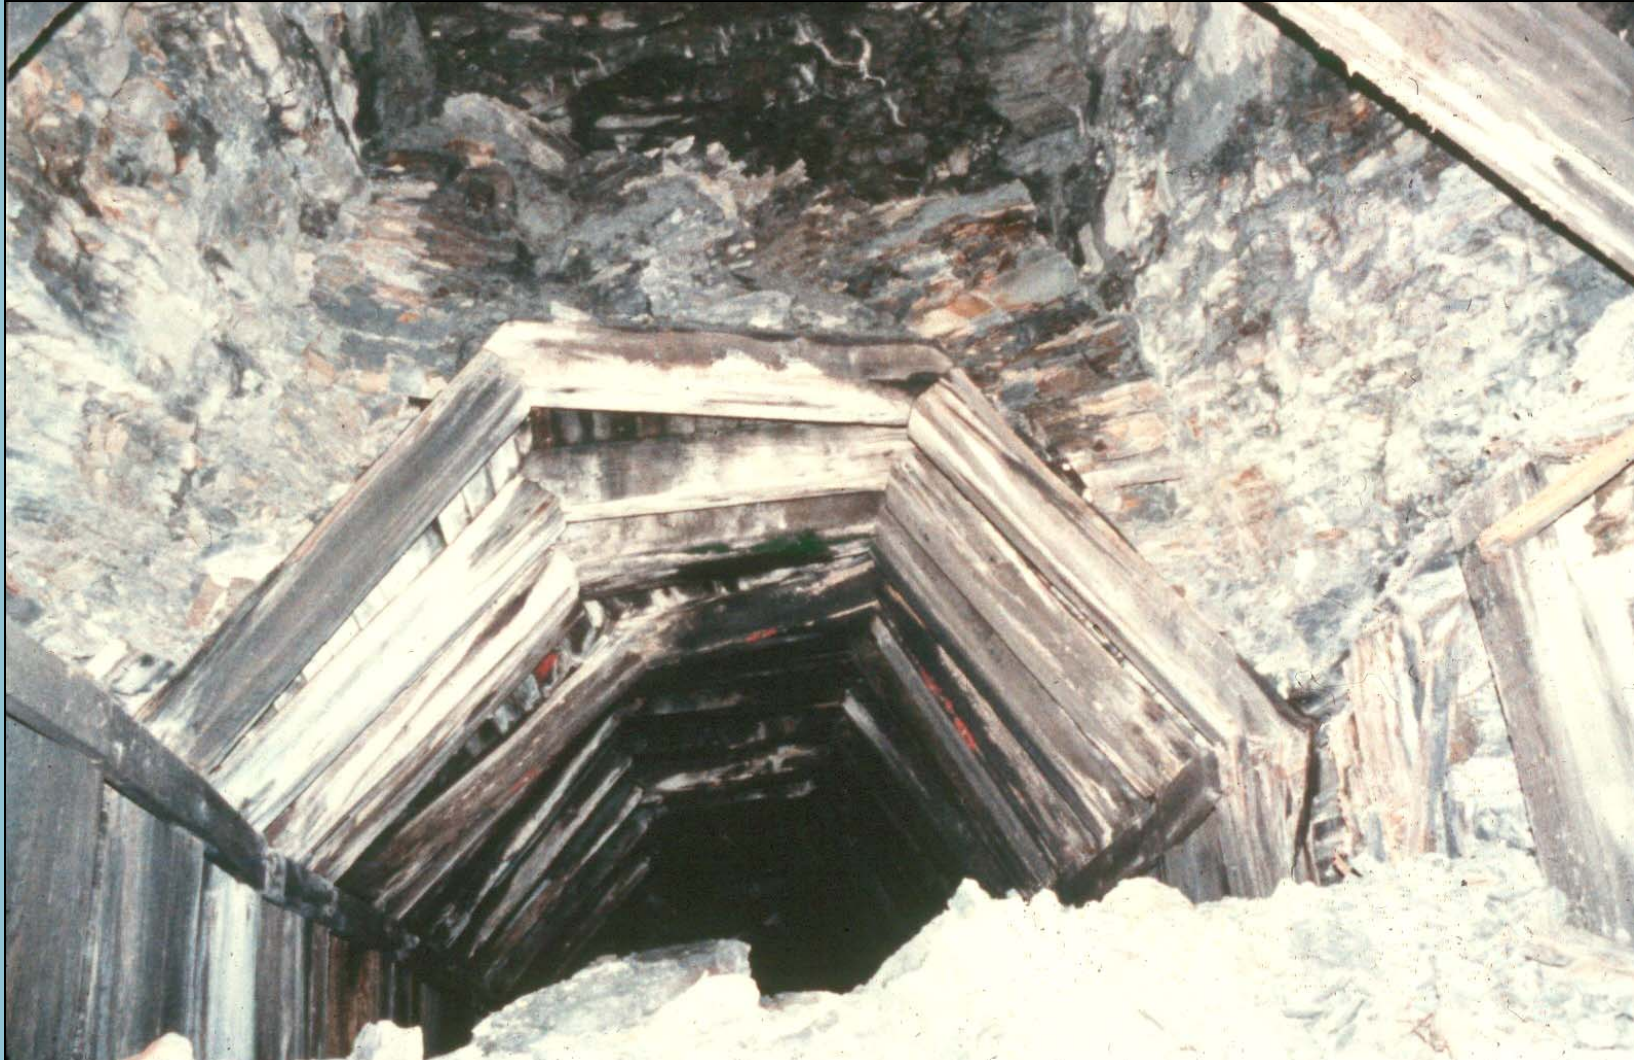
# Dead Load on Wooden Sets

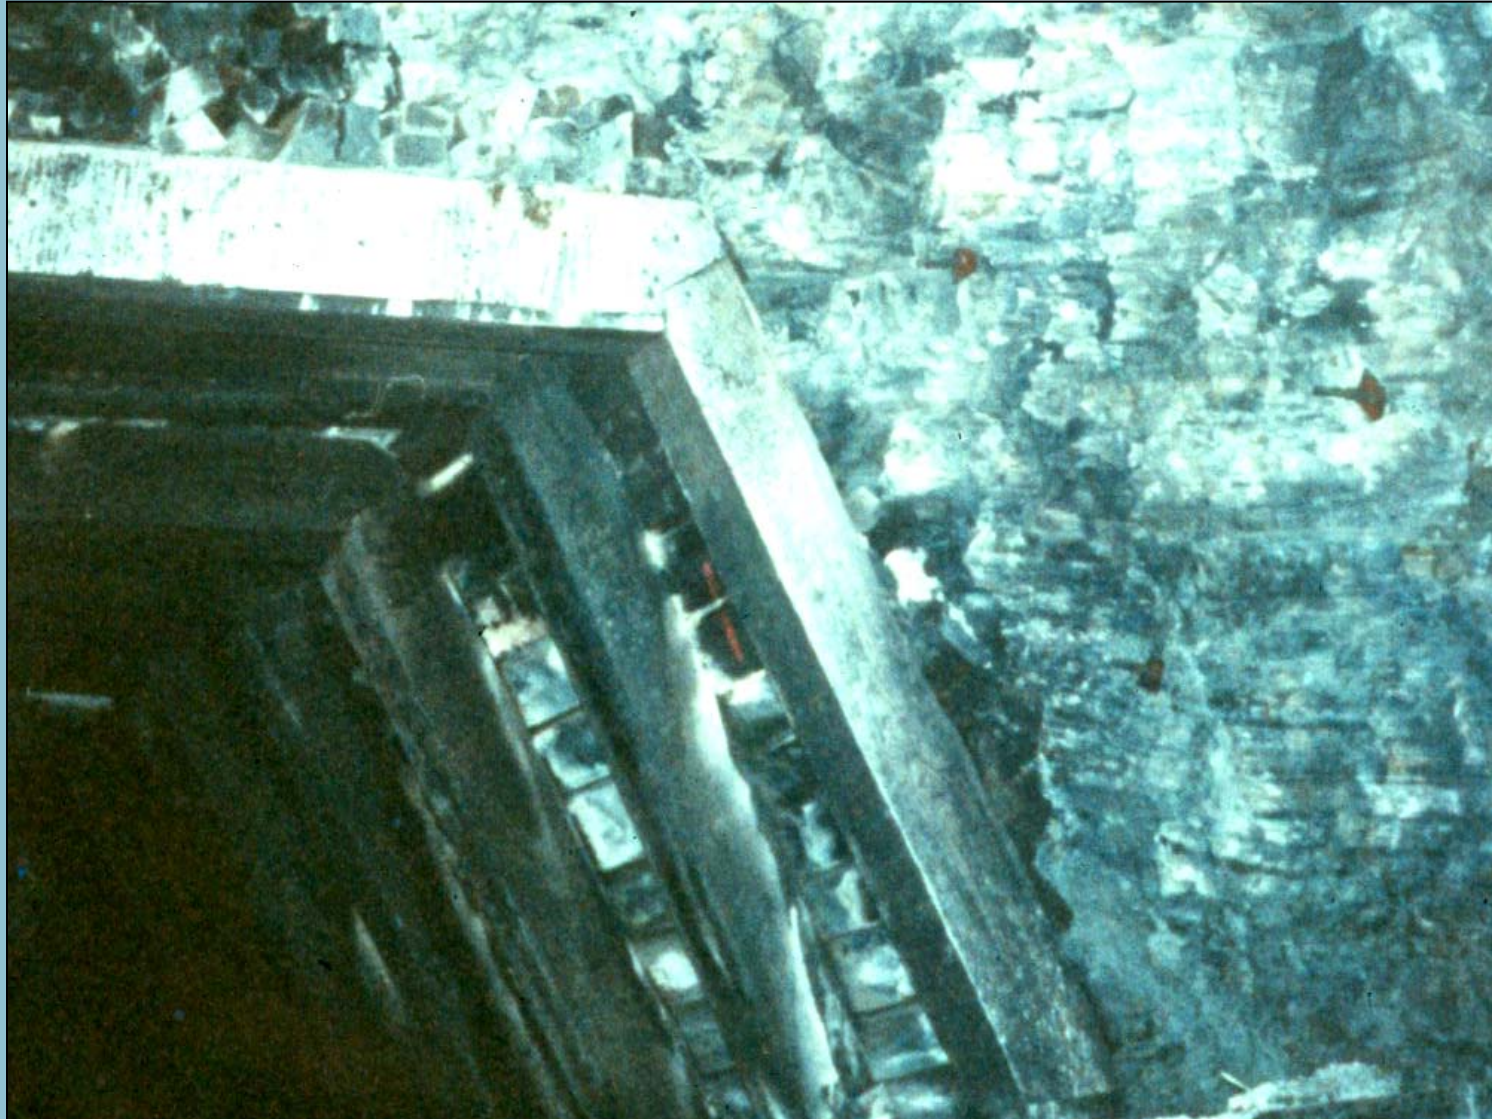
# Initial Repairs – Scaling and Rock Bolting

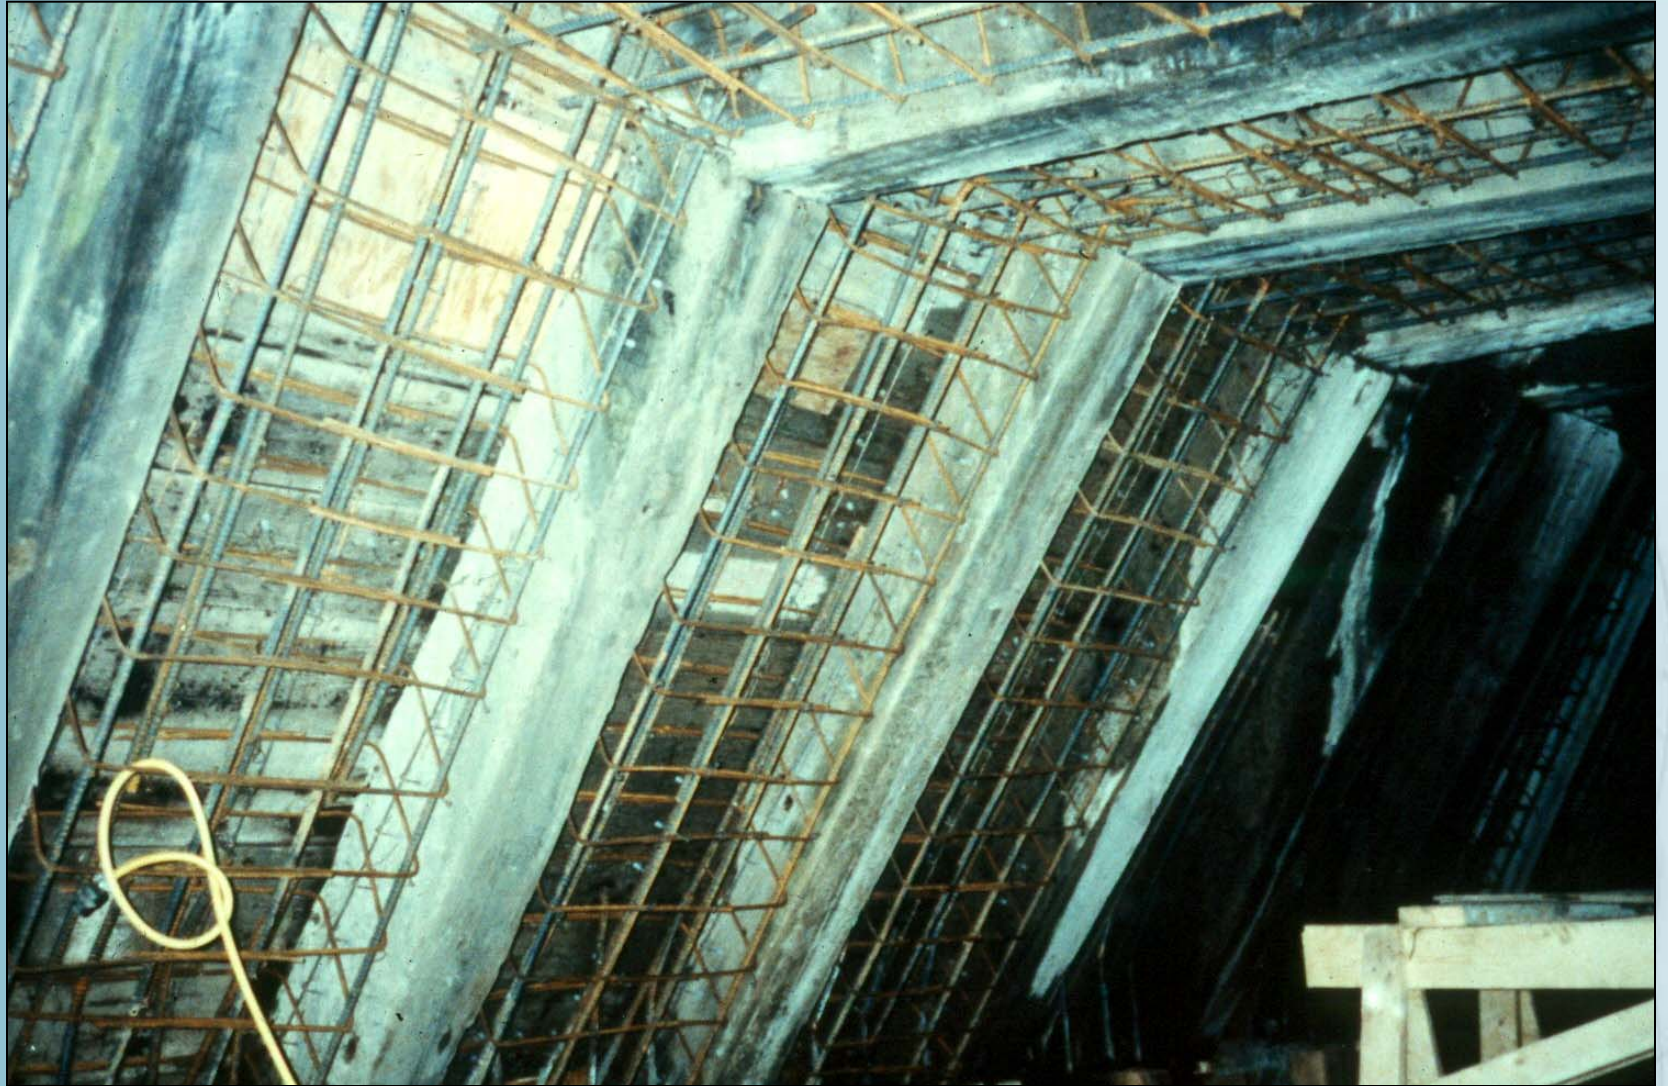
# Concrete Reinforcing of Wooden Sets in Problem Areas

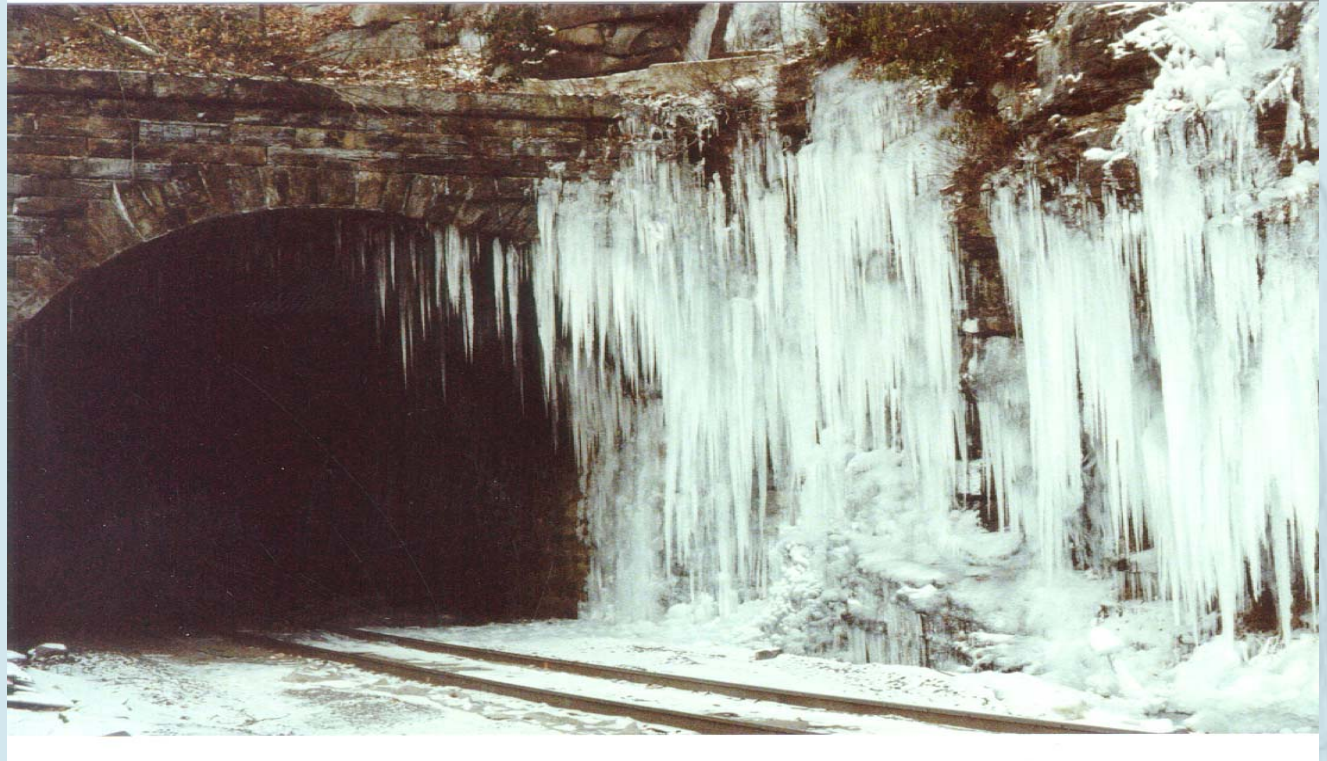
**INITIAL ICE CONDITIONS AT NORTH PORTAL  
OF ROCKPORT TUNNEL**

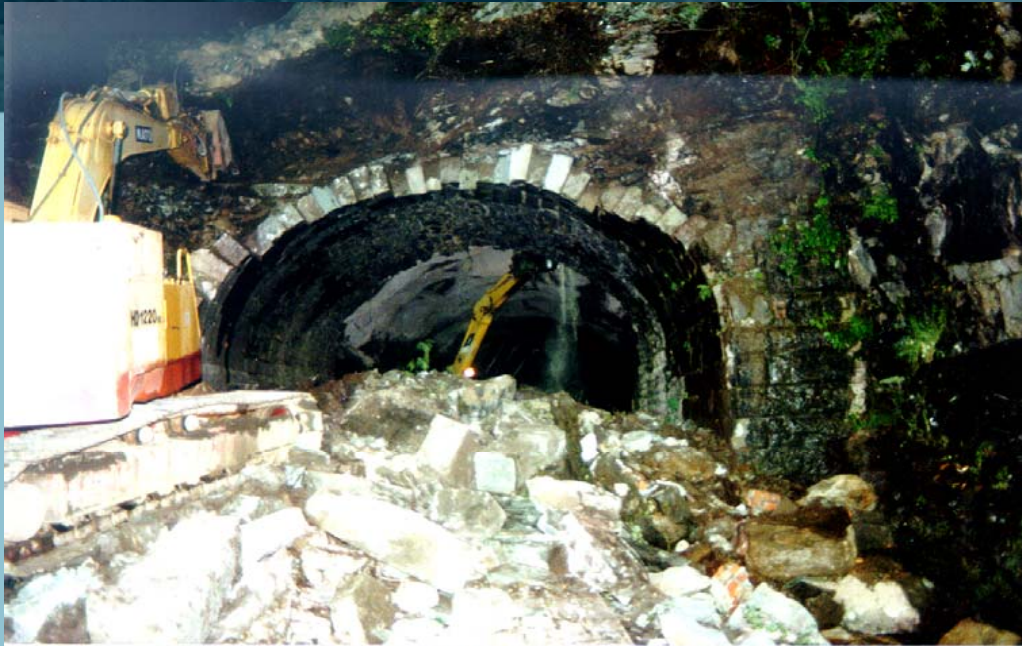
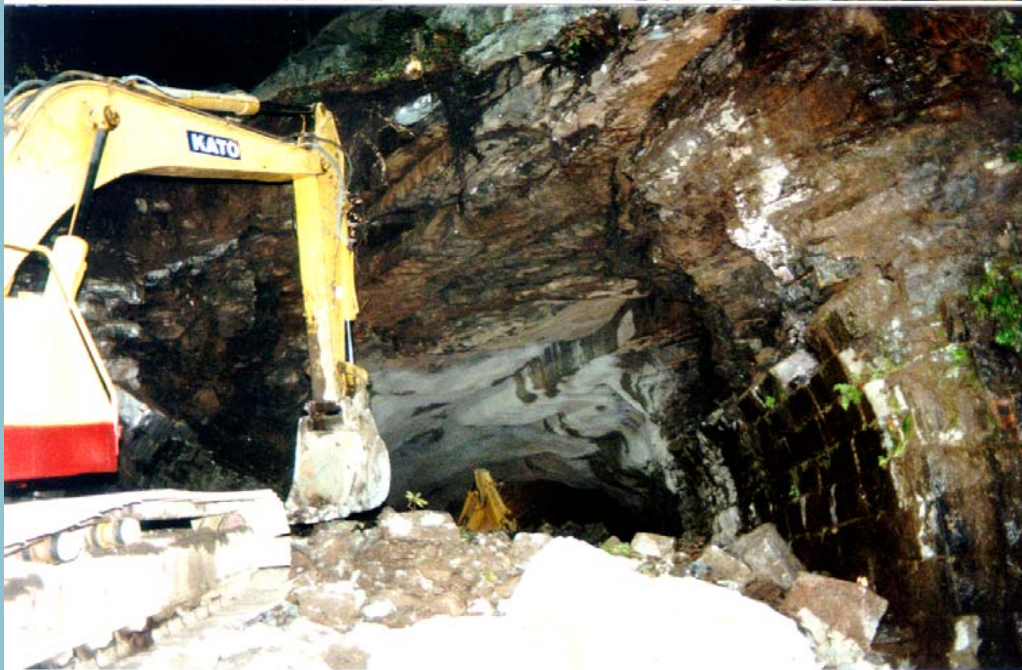
Pre-Support Then  
Removal of  
Structurally Unsound  
Lining

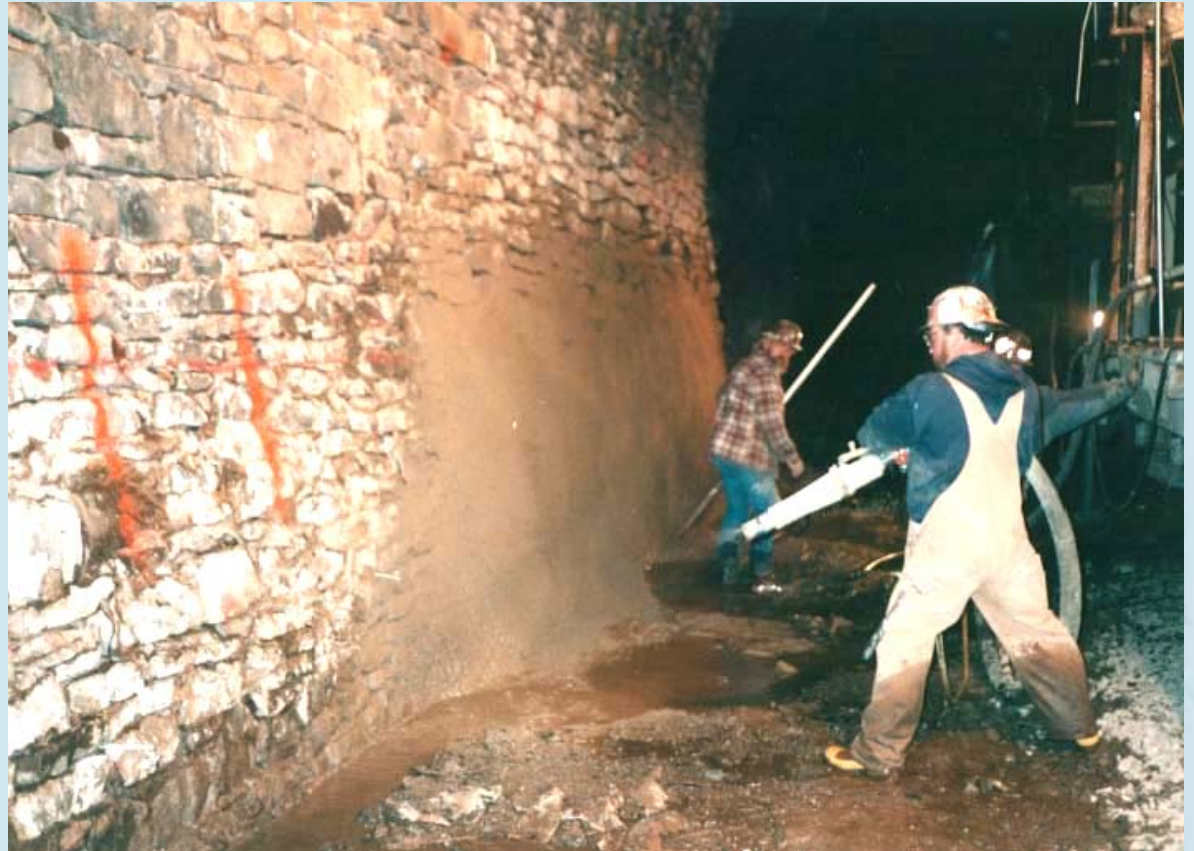
Rock Bolting from  
Work Platform

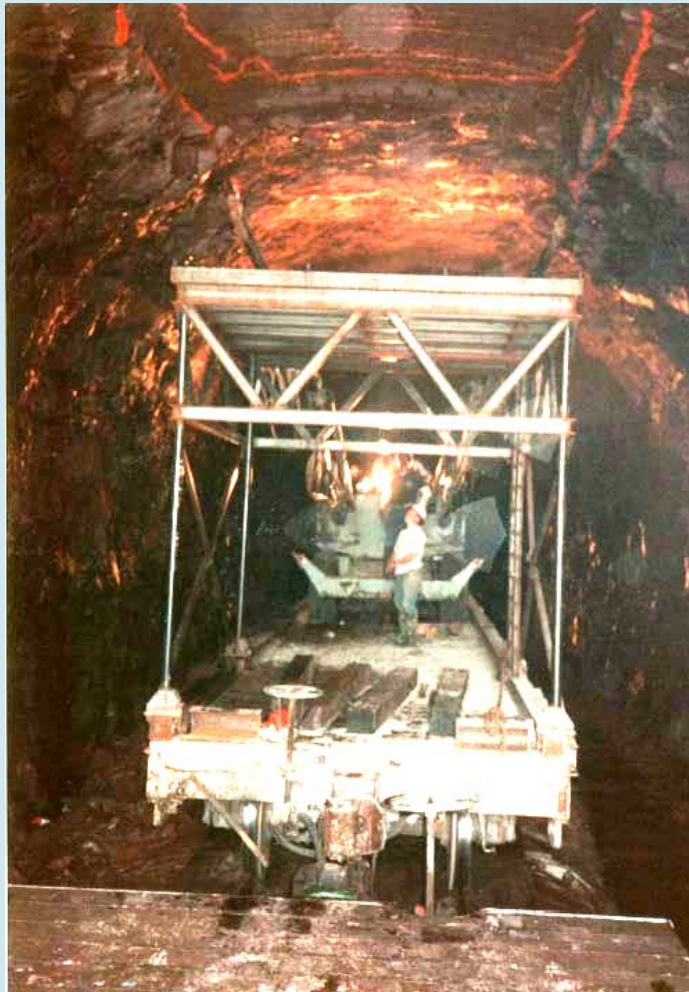
# Whitehaven Tunnel Notching Crown to Increase Clearance

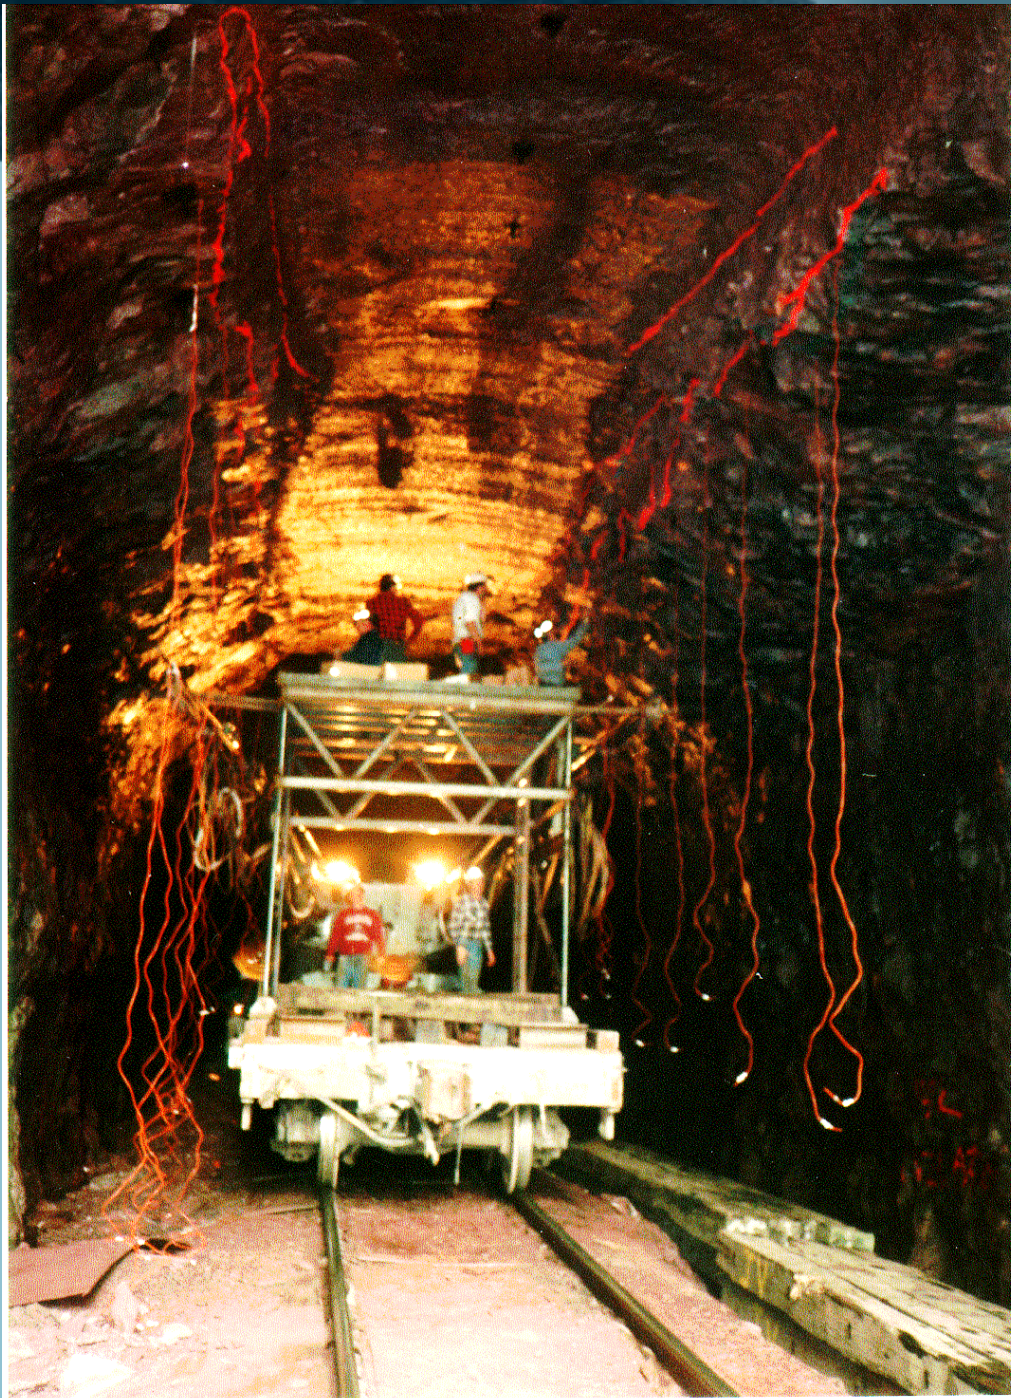
Re-blasting of cuts due  
to insufficient extent of  
roadheader notch

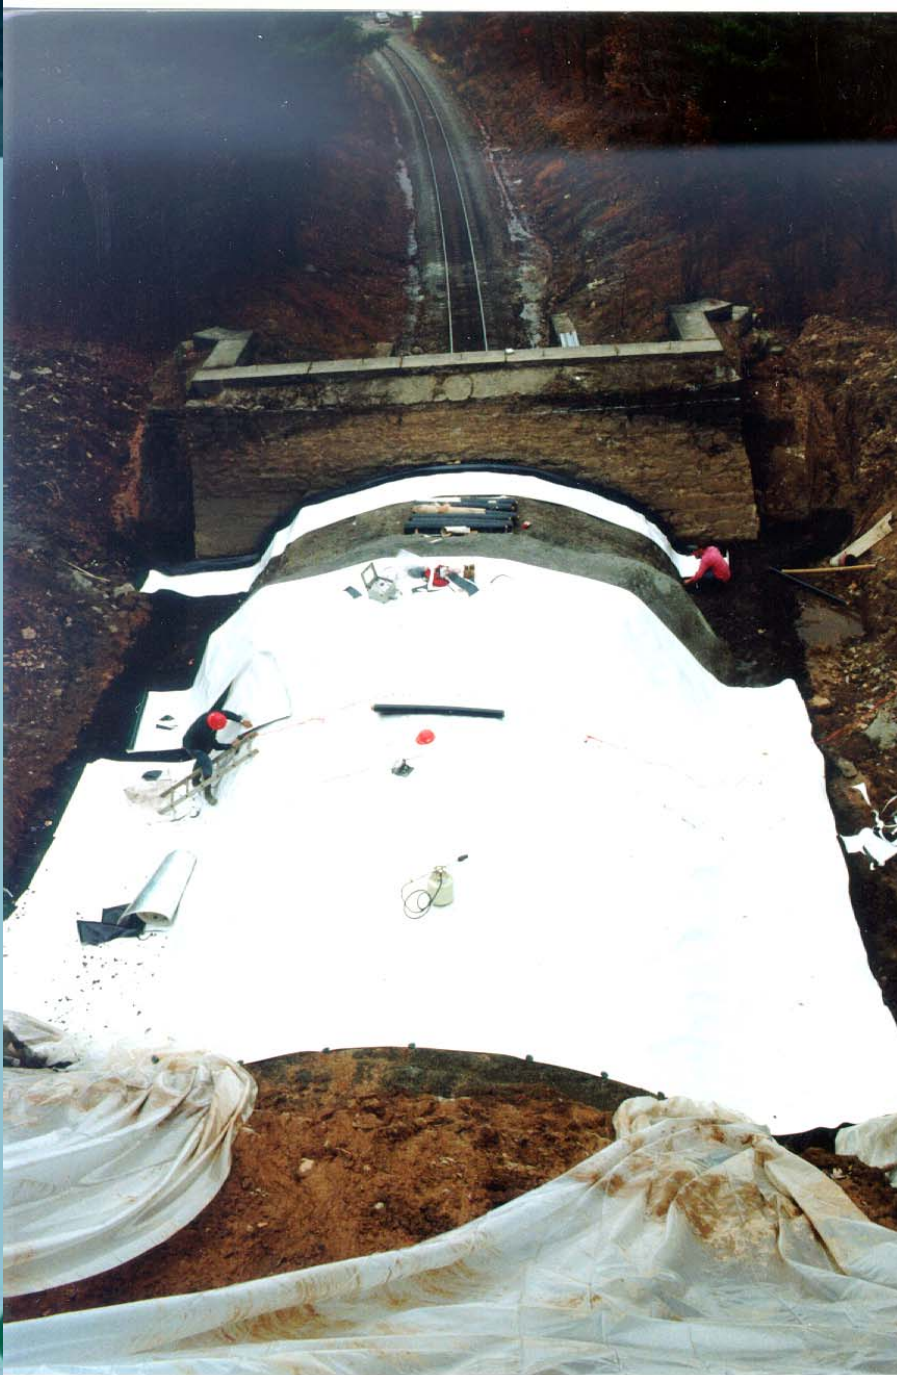
Excavation of Tunnel Cover

Support with bolts and  
shotcrete

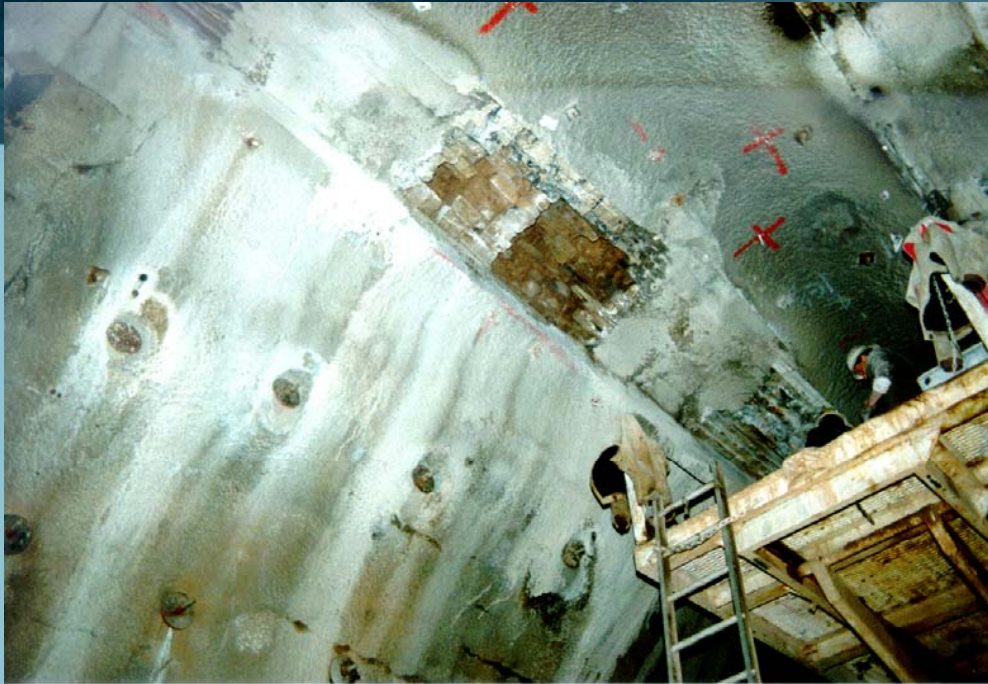
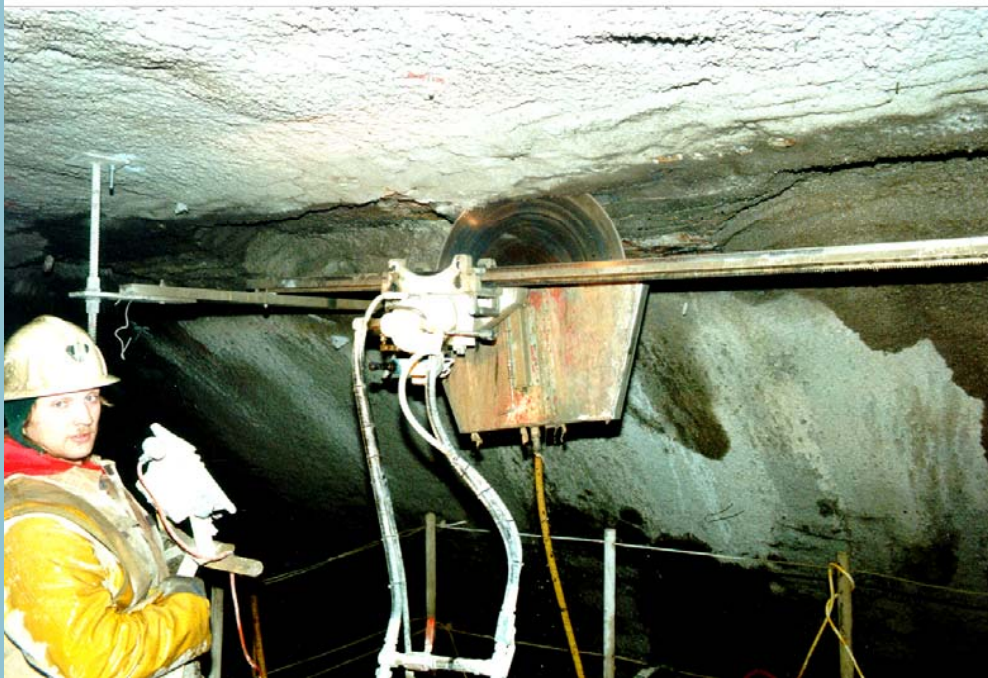
Saw notching of reinforced  
portal area

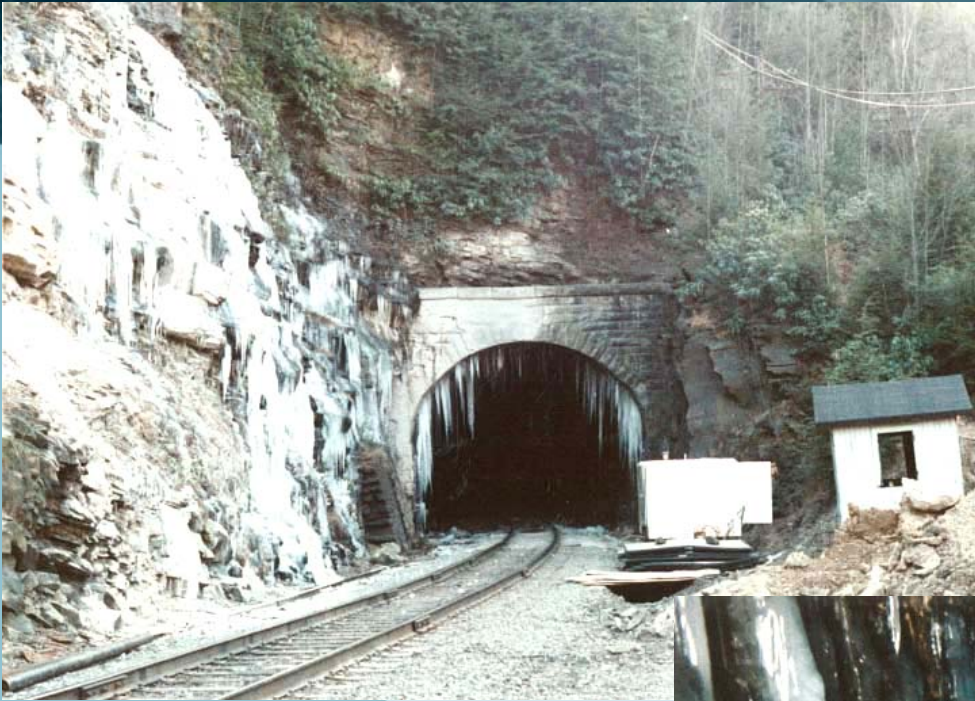
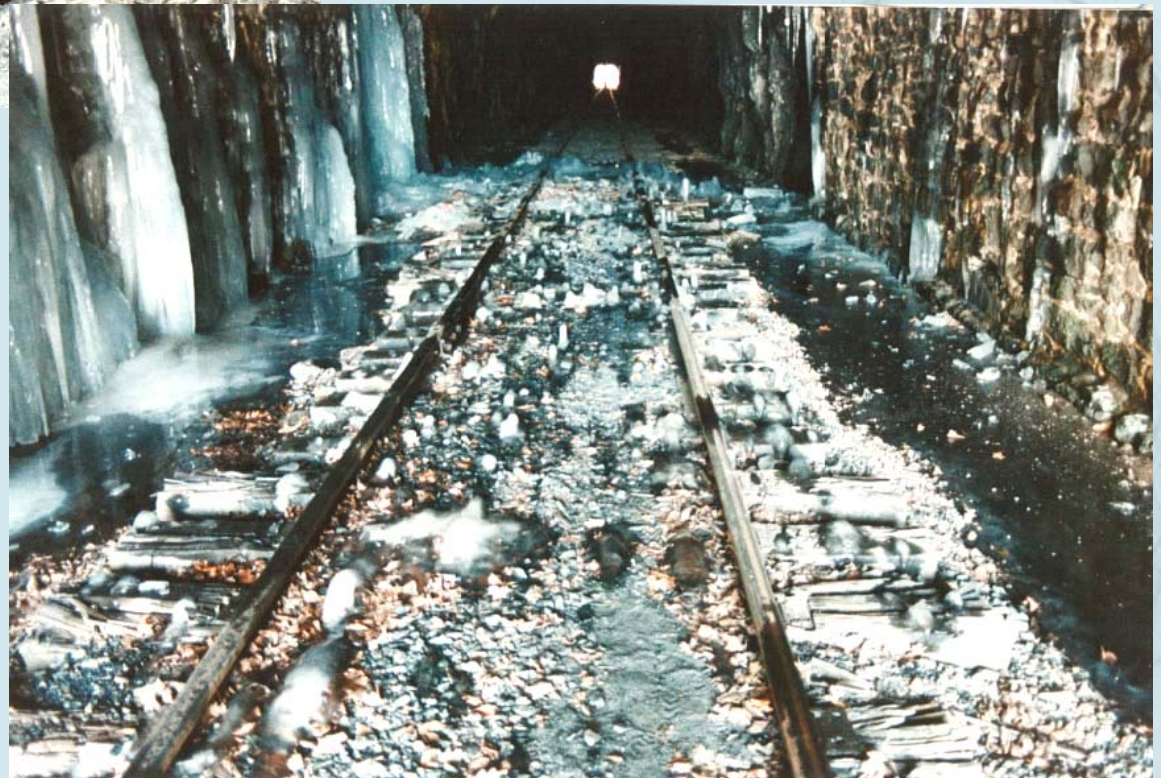
# Tunnel Ice and Drainage Problems

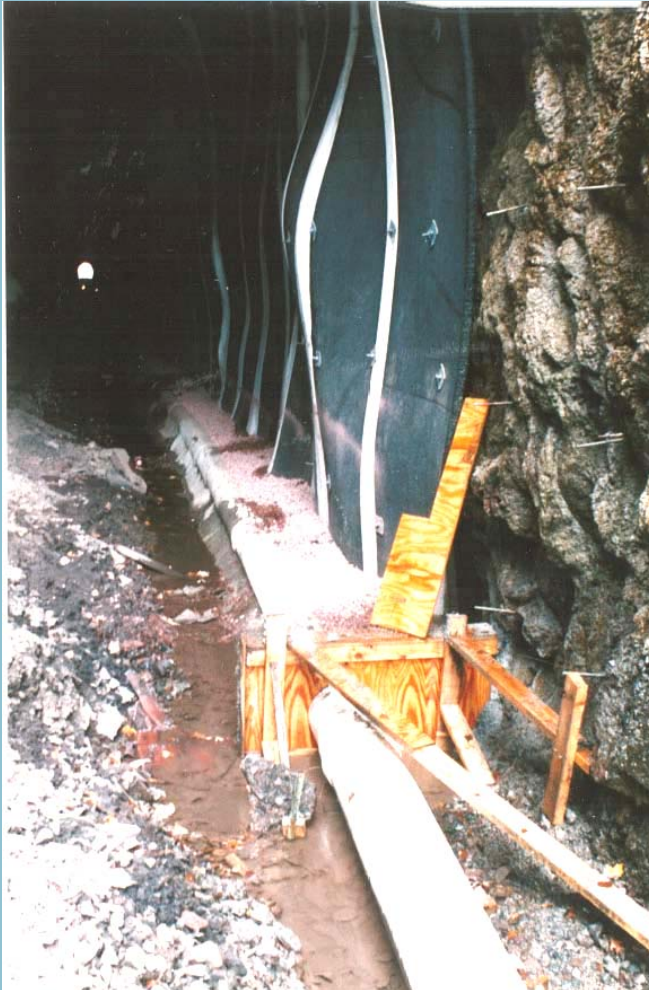
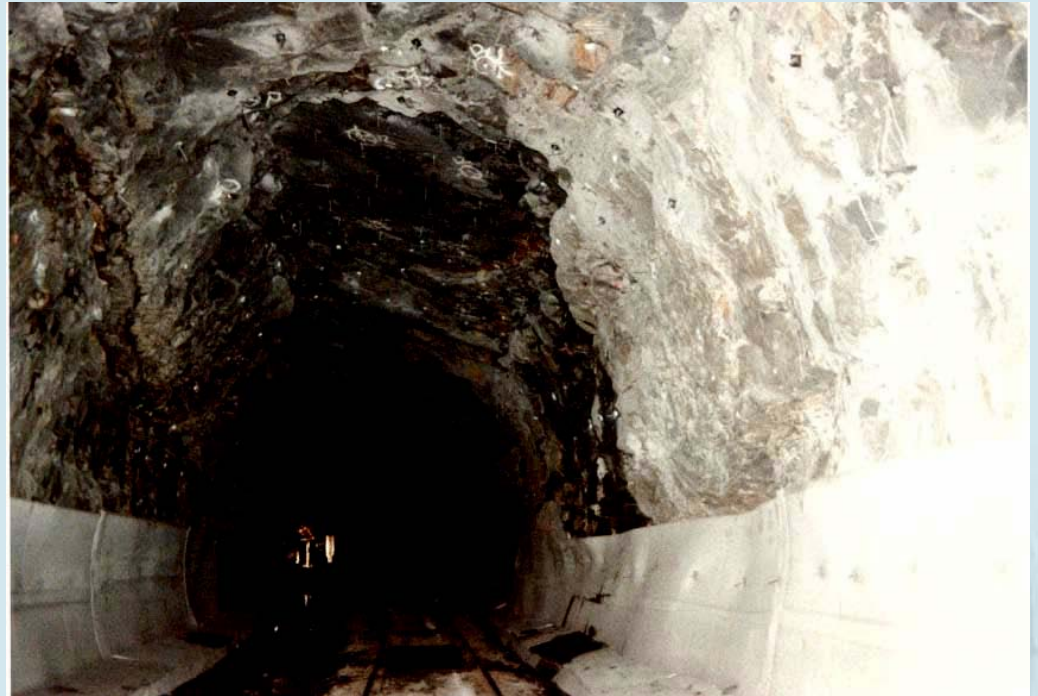
# Tunnel Drainage

Construction of Insulated Drains

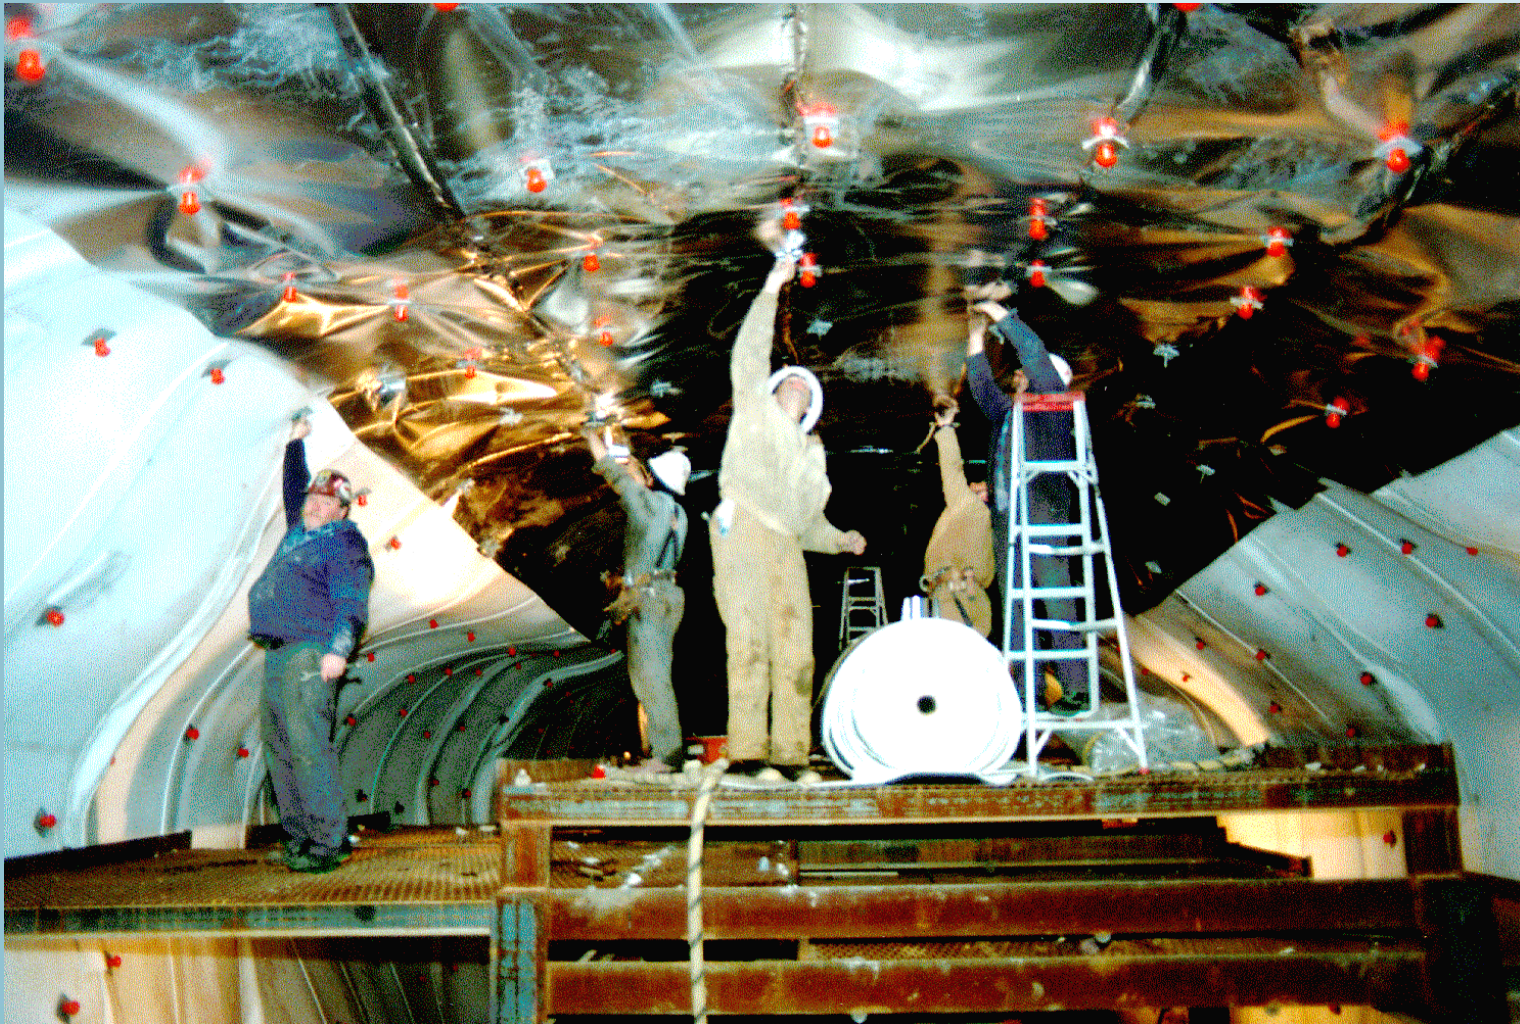
## INSULATION SPARK DEFLECTOR INSTALLATION

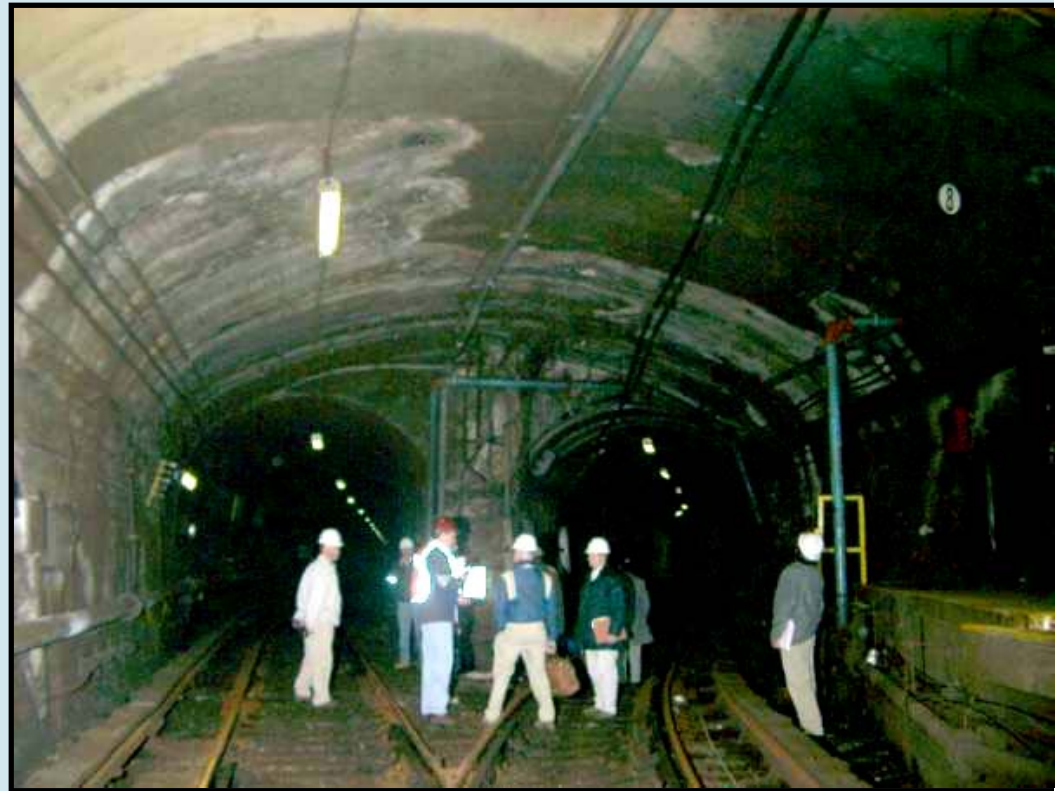
Typical Section

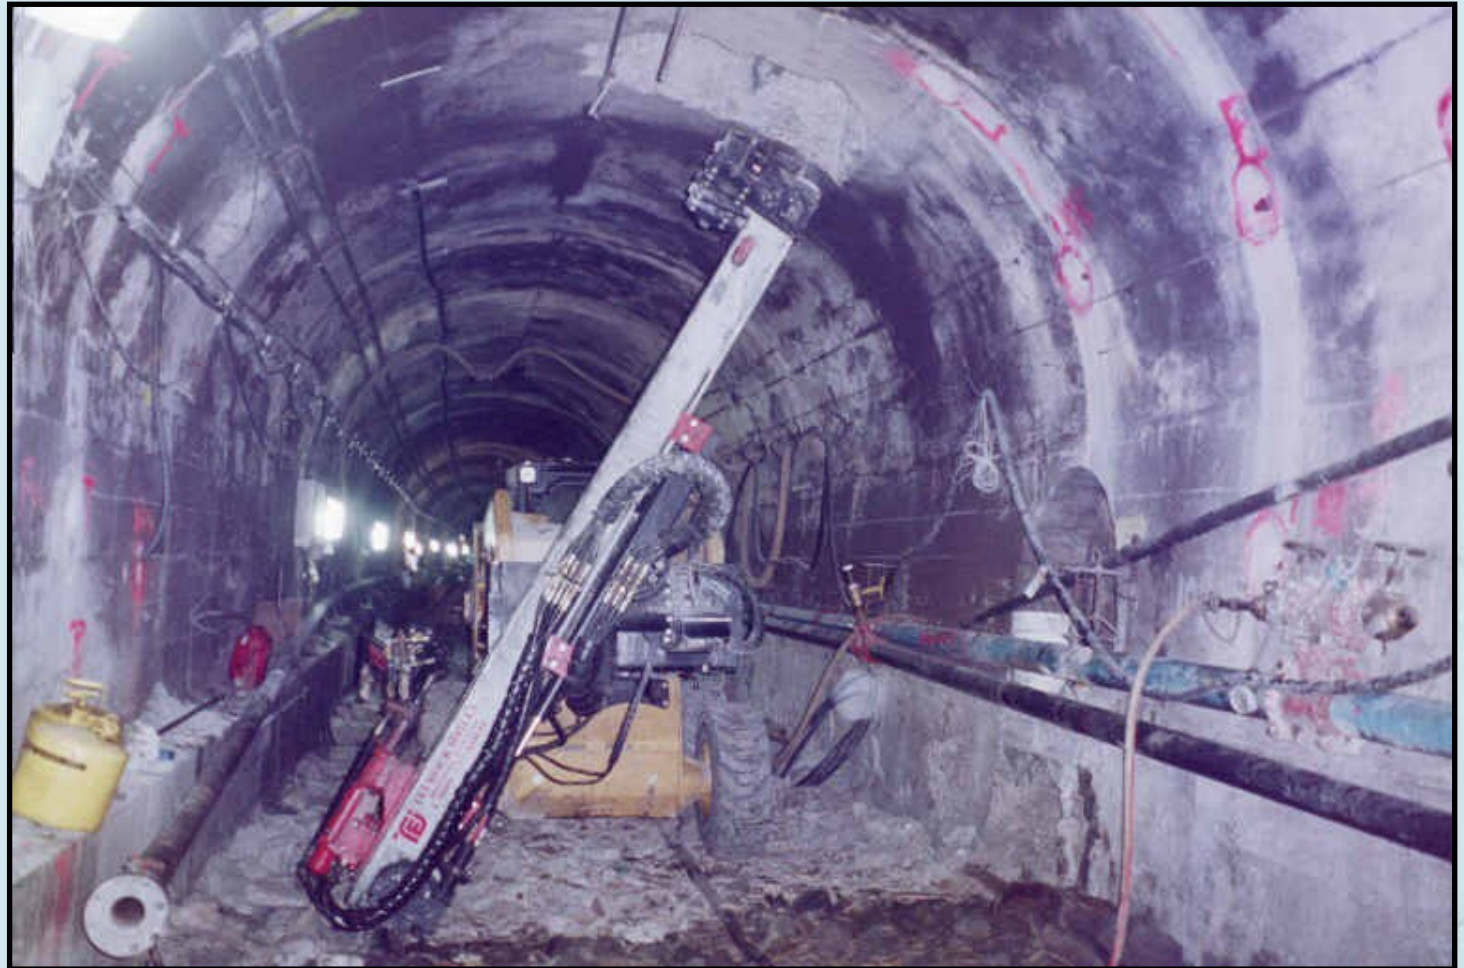
# Pre-Support Reinforcement

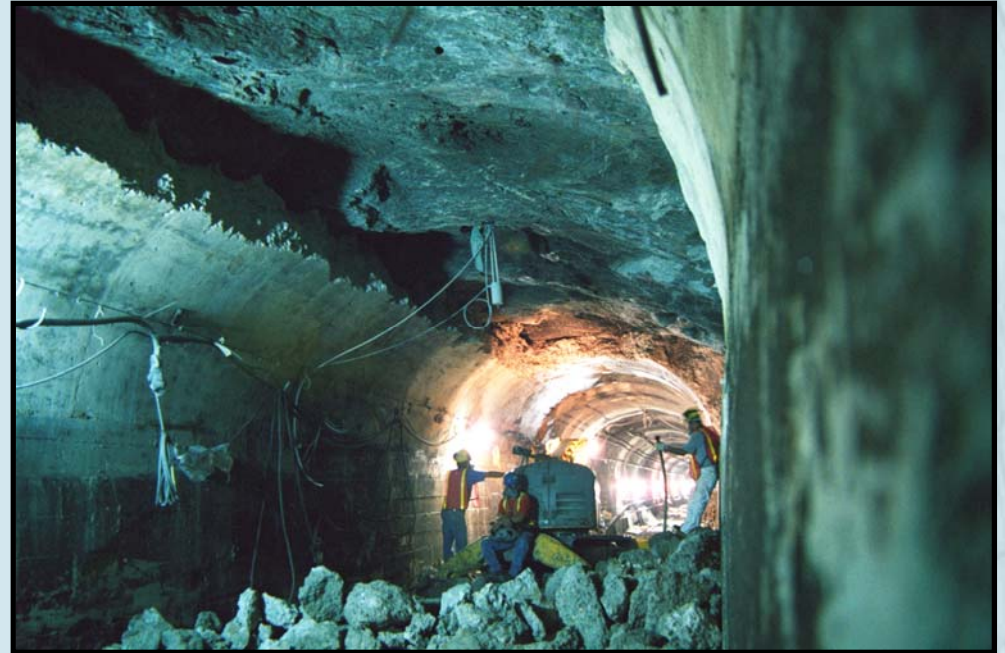
## Concrete Liner Removal
